AGENDA  
NATURAL RESOURCES COMMITTEE  
REGULAR MEETING  
**THURSDAY, SEPTEMBER 5, 2024 – 9:00 AM**  
**ADMINISTRATION CENTER - ROOM A-200**  
121 W. MAIN STREET, PORT WASHINGTON, WI 53074

- 1) Request by Michael Frede, as agent for Venturespace LLC, to petition the Natural Resources Committee for a Zoning Classification change Shoreland-Wetland to Shoreland in the Shoreland District, per Section 19.15600 of the Ozaukee County Shoreland Protection Ordinance, to reflect the results of a wetland delineation report and survey; and per Section 19.03500 to rezone all or part of the delineated wetlands to allow land disturbance activities for the purpose of a commercial building and parking area.

PROJECT: **WETLAND EXHIBIT**  
8535 S.T.H. 60  
CEDARBURG WI 53012

# GLENN HARSH PROPERTY WETLAND DELINEATION SITE PHOTOS

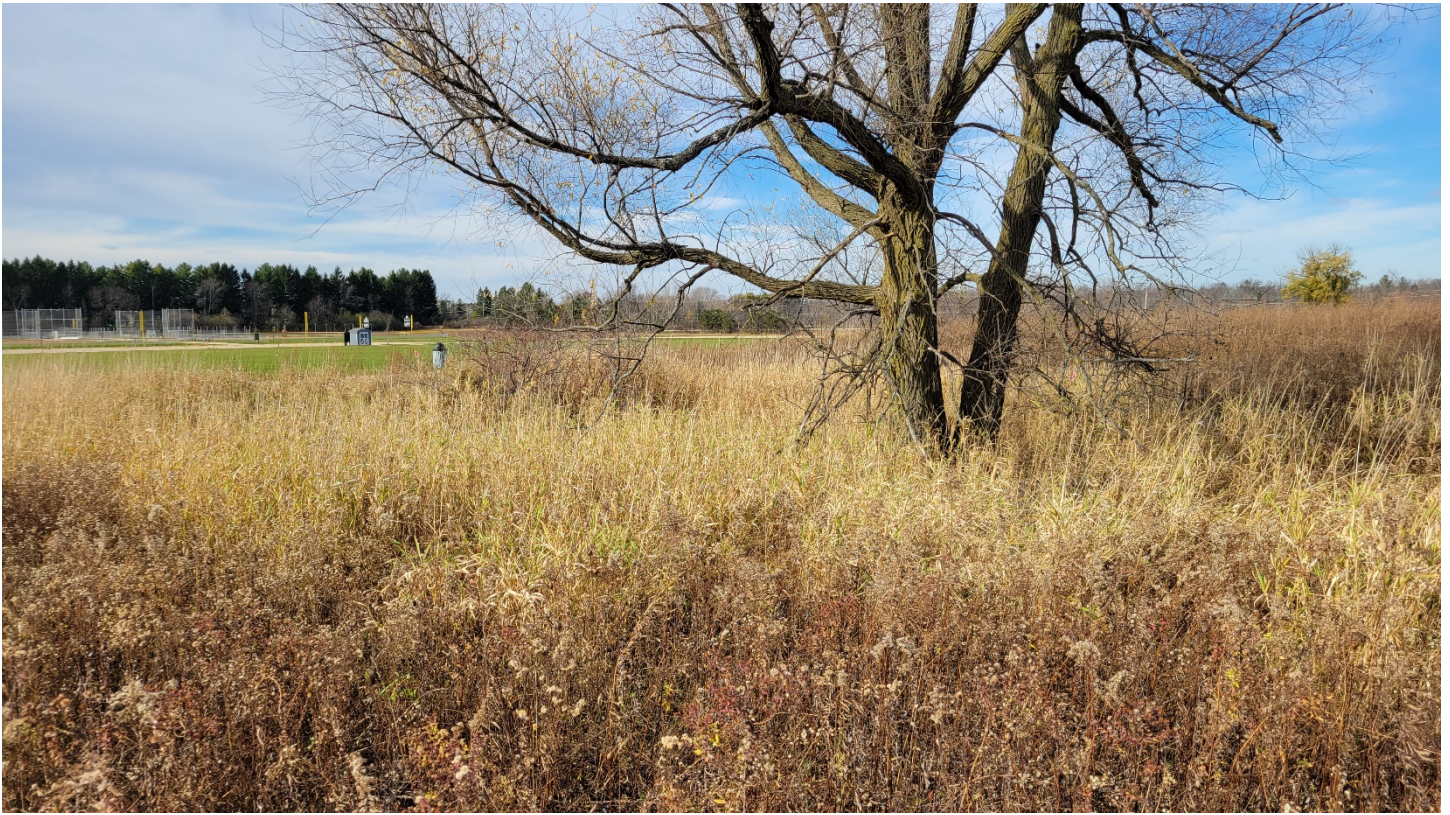
Wetland A is a disturbed wet meadow wetland on the west side of the site, near the access road.

The wetland delineation shows that **Wetland A** is dominated by reed canary grass and black willow. **Wetland D** is dominated by purple loosestrife, reed canary grass, and frost and calico aster.

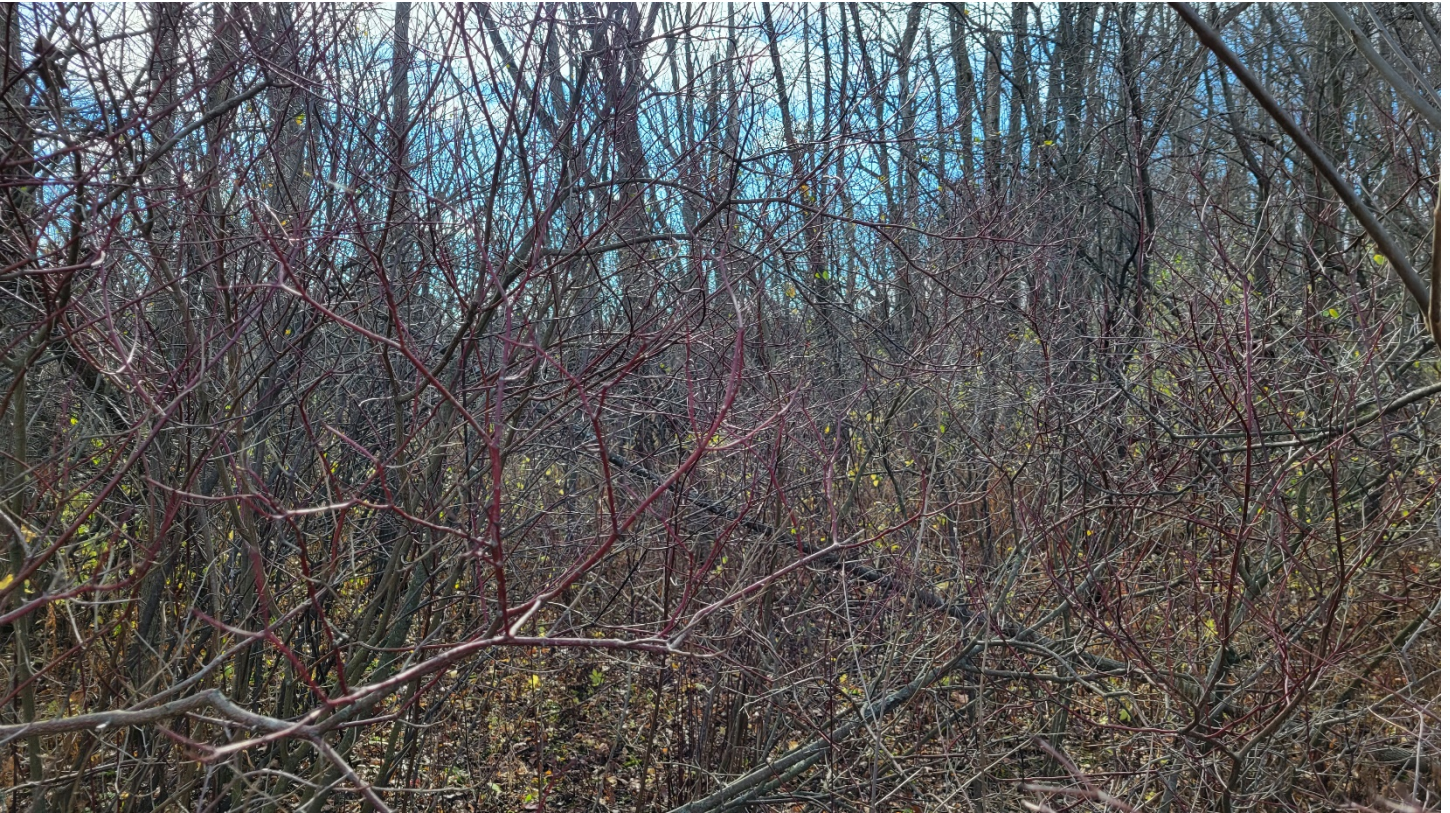
View of Wetland B. DP3 was taken at the toe of slope and had dominant species which included green ash, common buckthorn, white avens, and river bank grape.

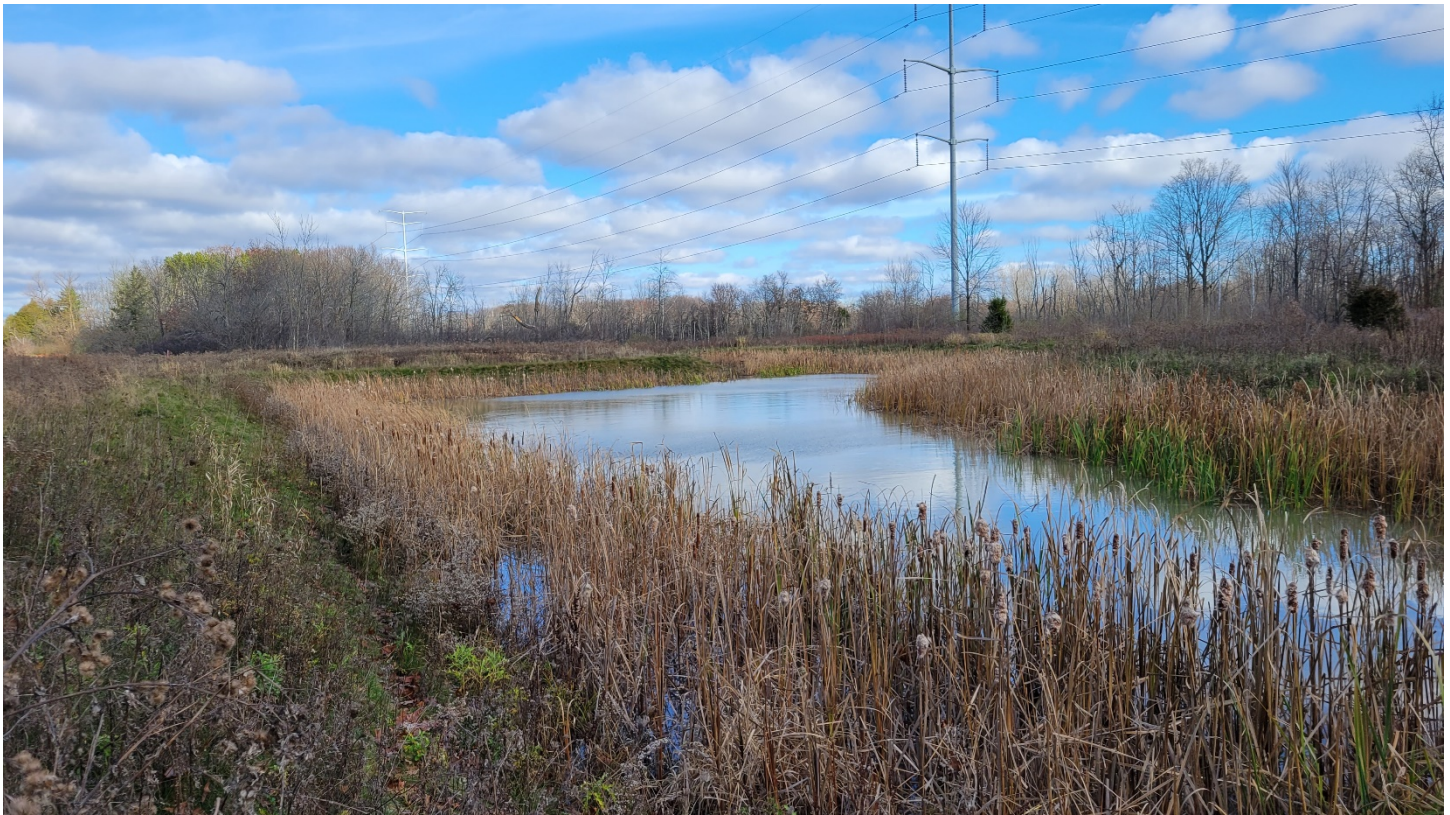
Wetland C is an open stormwater pond with an emergent wetland fringe. The dominant species was narrow-leaved cattail.

**Wetland C** is an open stormwater pond with an emergent wetland fringe in the center of the east side of the site. DP5 was taken at the toe of slope and the dominant species was narrow-leaved cattail. The soils met the criteria for F6. Redox Dark Surface. There were three inches of standing water in the plot. The hydrology indicators included Surface Water, Inundation Visible on Aerial Imagery, Geomorphic Position, and FAC-Neutral Test. The adjacent upland point (DP6) was located on a hillslope of a berm in old field where the dominant species were Kentucky bluegrass and frost aster. The sample point lacked hydric soils and wetland hydrology.

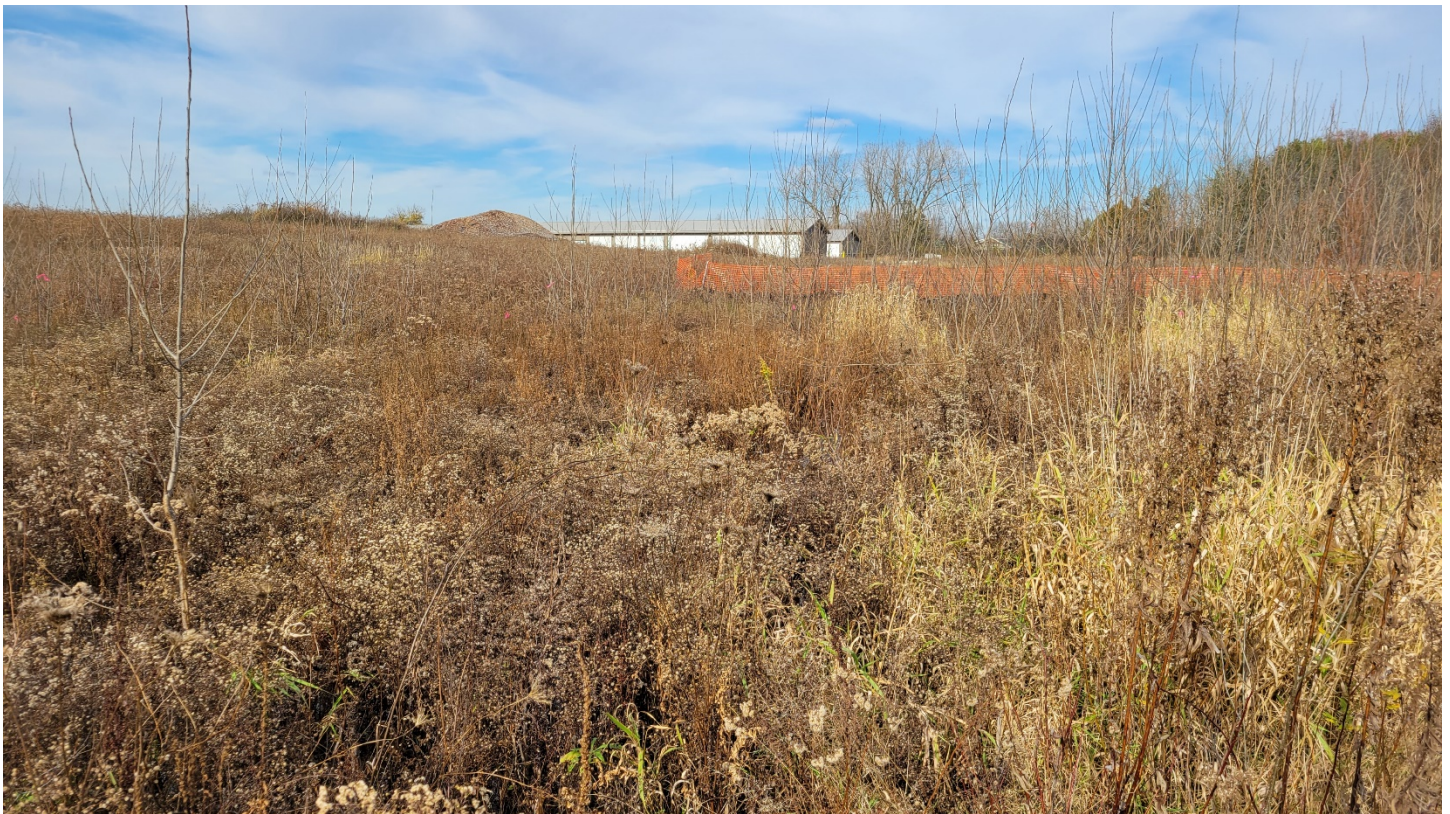
View of Wetland D, which was a disturbed wet meadow wetland dominated by eastern cottonwood, purple loosestrife, and reed canary grass.

**Wetland D** is a disturbed wet meadow wetland west of the stormwater pond. DP11 was taken in a closed depression and the dominant species were eastern cottonwood, purple loosestrife, and reed canary grass. The soils met the criteria for F3. Depleted Matrix. There were two inches of standing water in the plot and the hydrology indicators included Surface Water, Geomorphic Position, and FAC-Neutral Test. The adjacent upland point (DP12) was located on a hillslope in old field where the dominant species were autumn olive, Kentucky bluegrass, and Canadian goldenrod. The sample point lacked hydric soils and wetland hydrology.

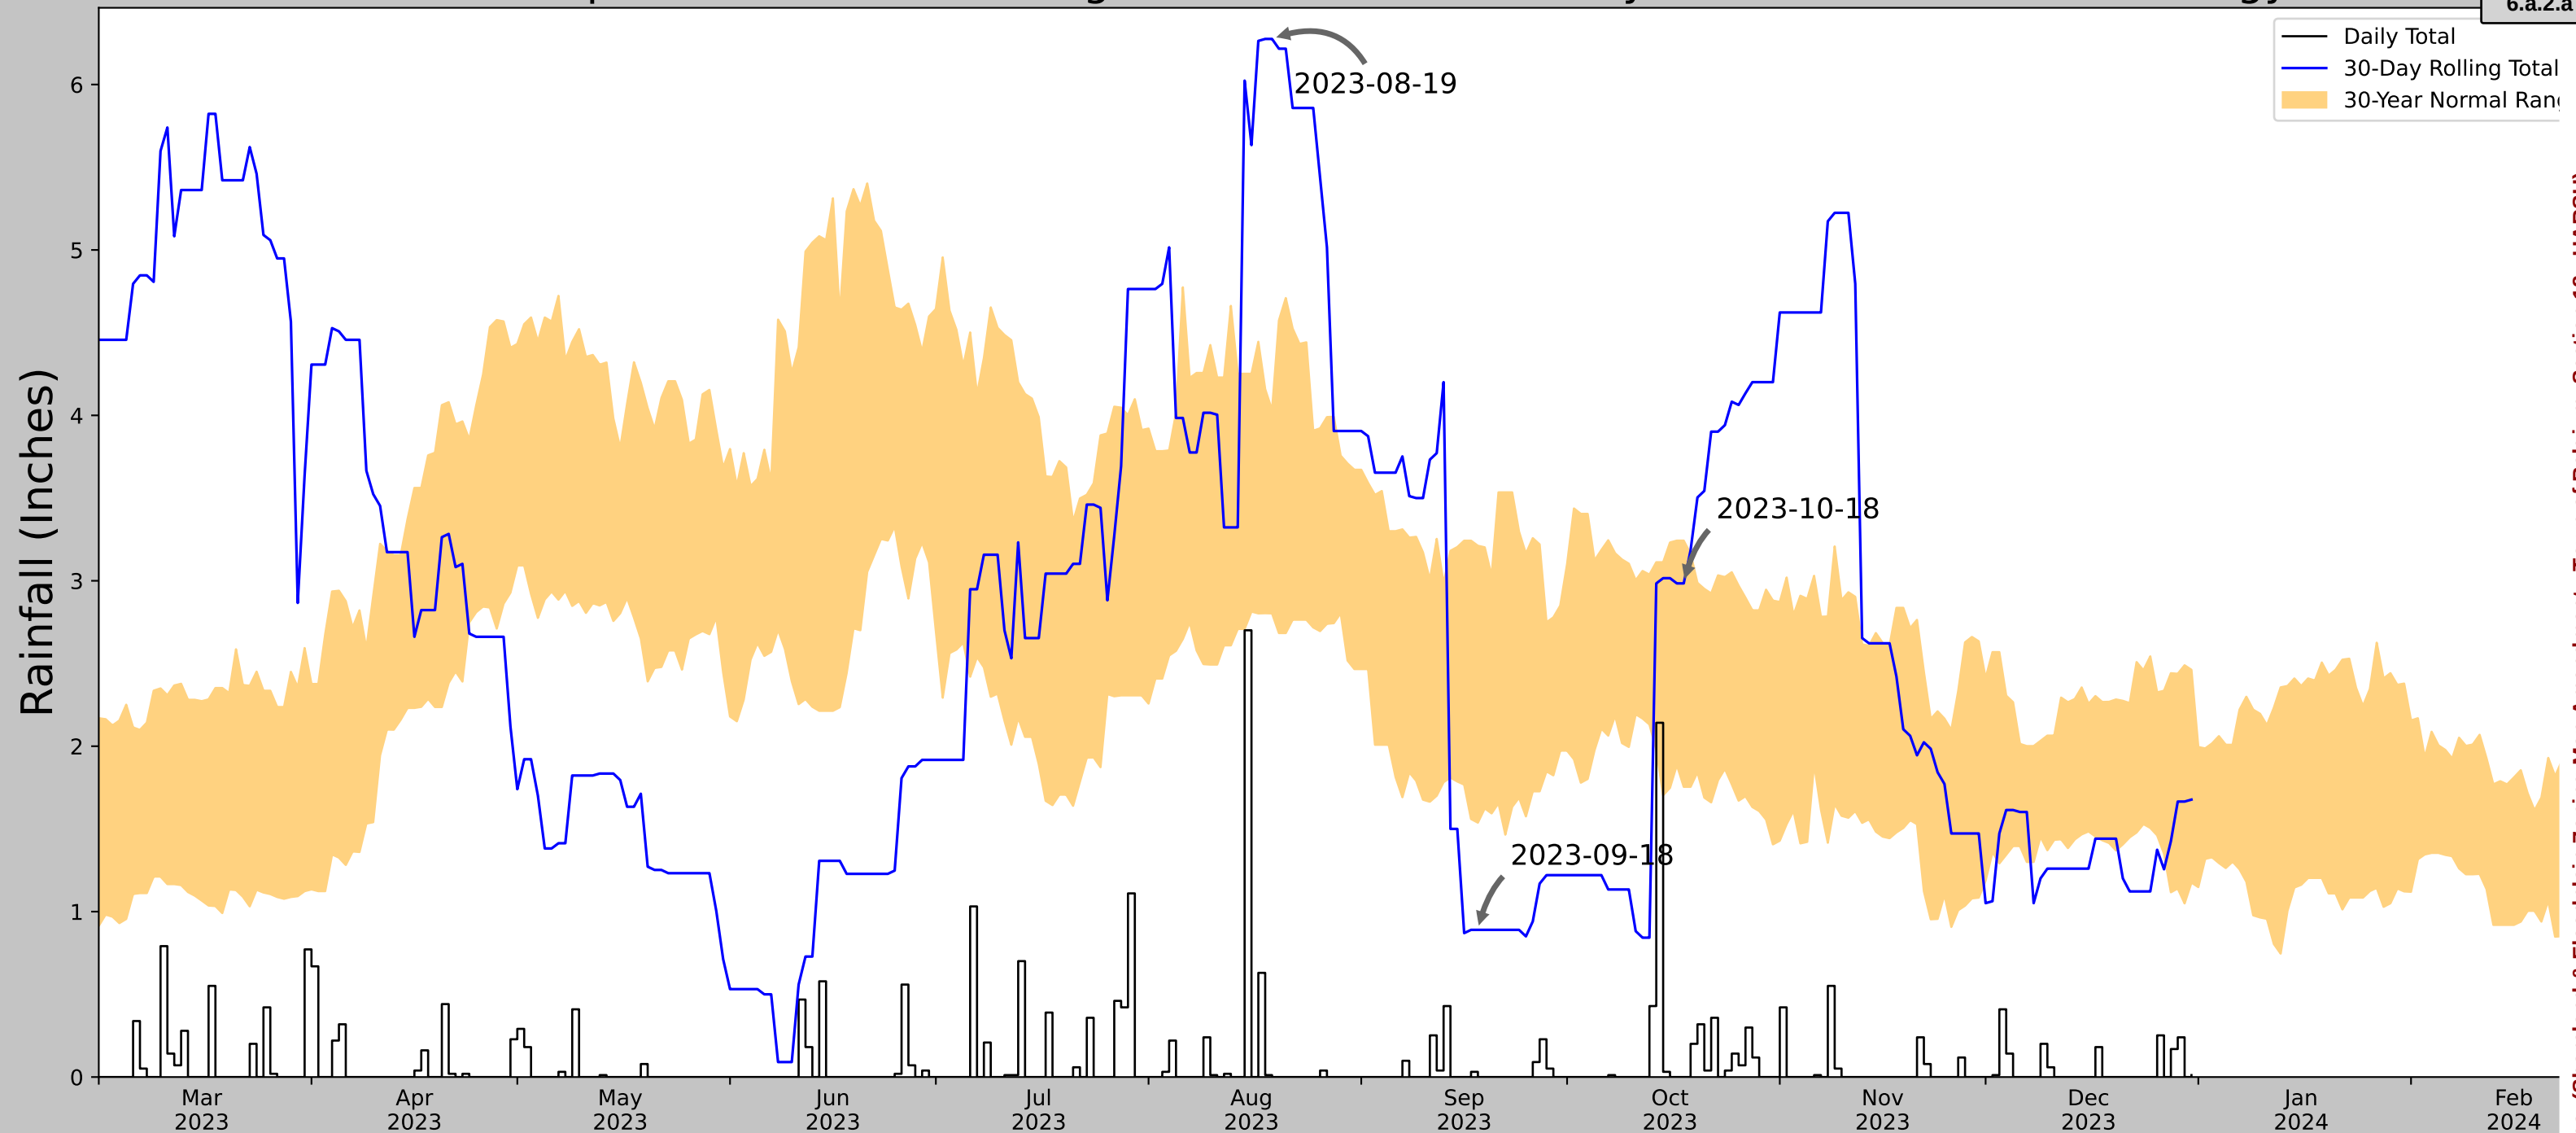
| 30 Days Ending | 30 <sup>th</sup> %ile (in) | 70 <sup>th</sup> %ile (in) | Observed (in) | Wetness Condition | Condition Value | Month Weight | Product |
|---|---|---|---|---|---|---|---|
| Result | | | | | | | Normal Conditions - 11 |

Figure and tables made by the  
**Antecedent Precipitation Tool**  
Version 1.0

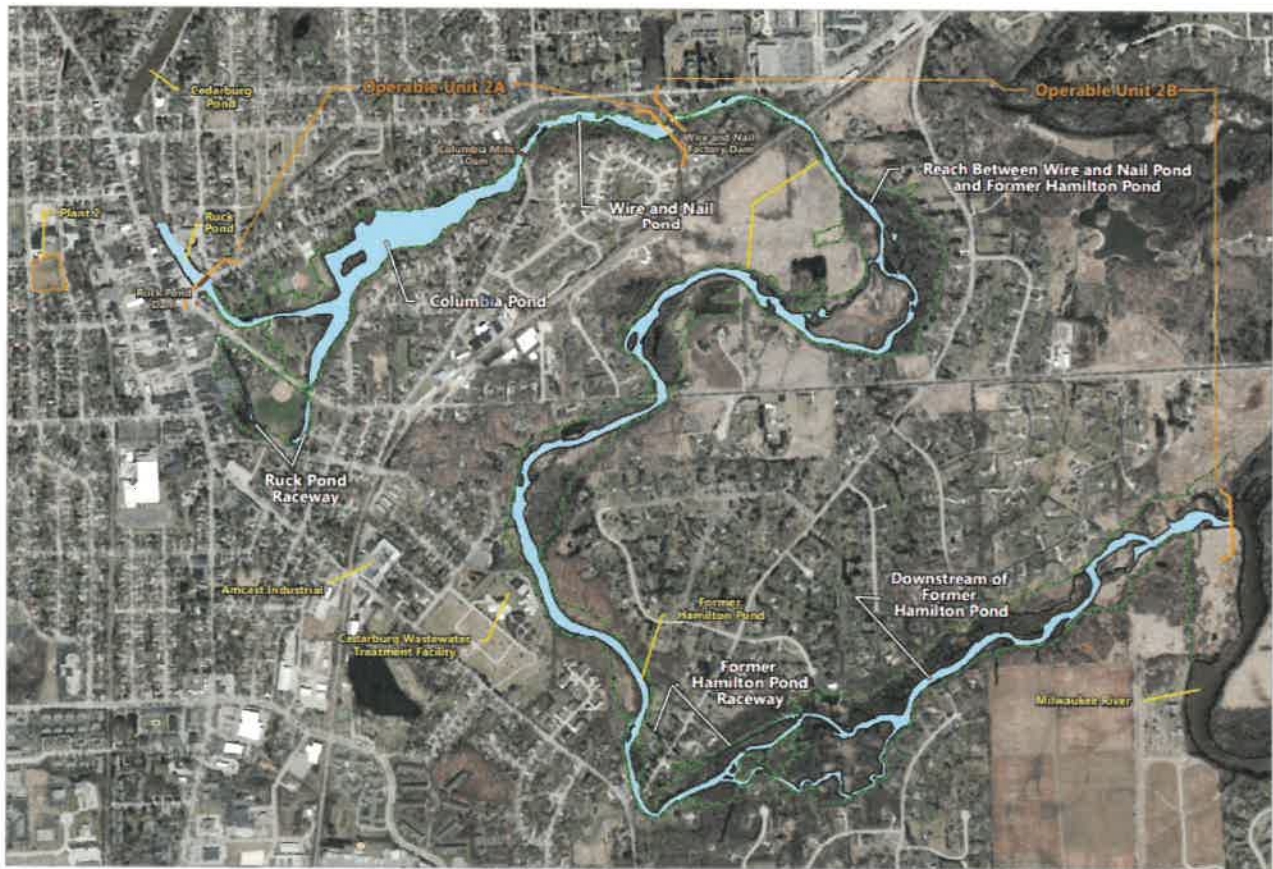
Aerial map of the Cedar Creek Superfund Alternative Site depicting the location of Operable Unit 2A and Operable Unit 2B.
