AGENDA  
OZAUKEE COUNTY BOARD  
REGULAR MEETING  
**WEDNESDAY, OCTOBER 2, 2024 – 9:00 AM**  
**ADMINISTRATION CENTER - ROOM A-204**  
121 W. MAIN STREET, PORT WASHINGTON, WI 53074

**WDNR PROFESSIONALLY ASSURED  
WETLAND DELINEATION REPORT**

GLENN HARSH PROPERTY  
WETLAND DELINEATION SITE PHOTOS

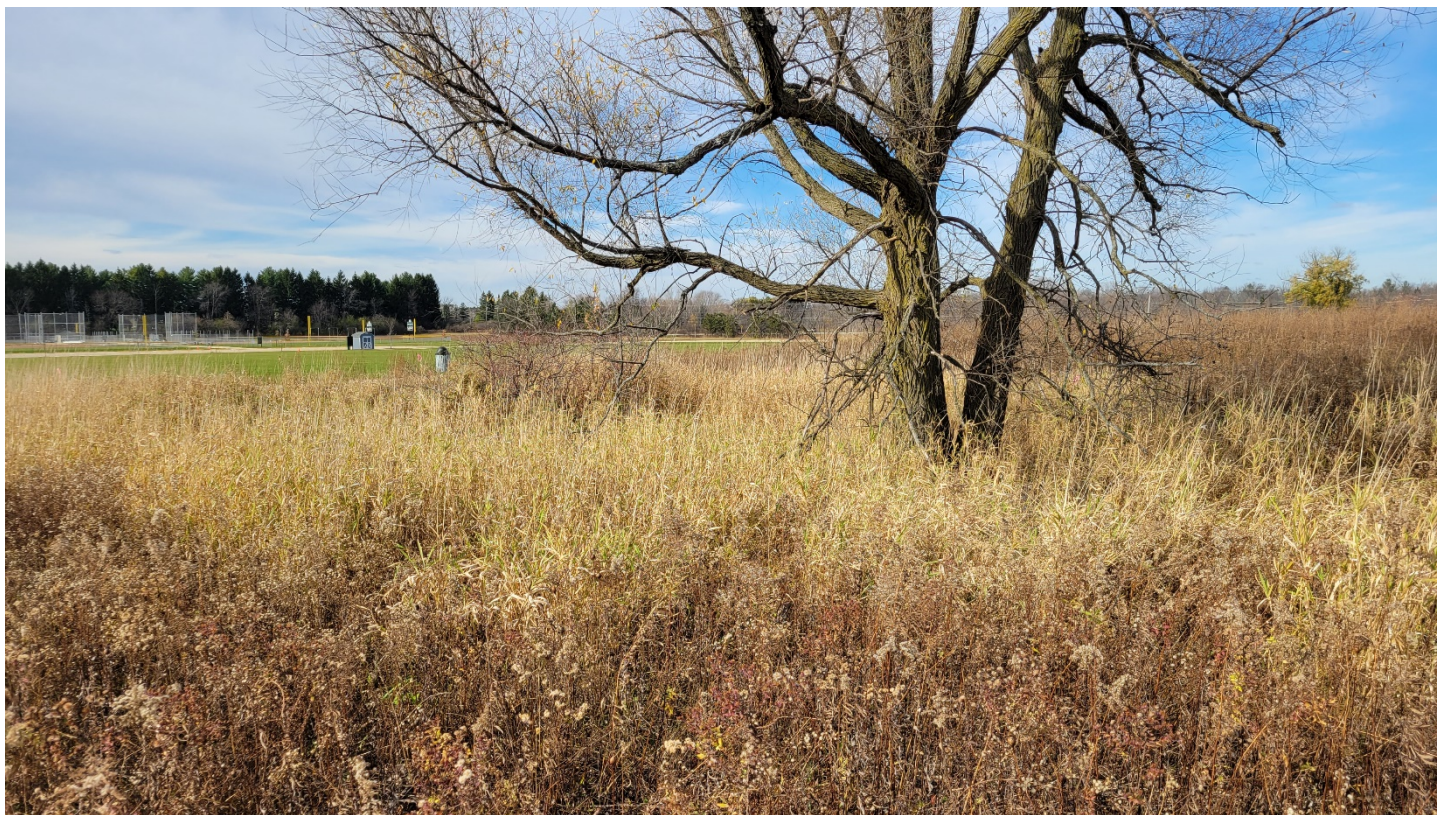
Wetland A is a disturbed wet meadow wetland on the west side of the site, near the access road.

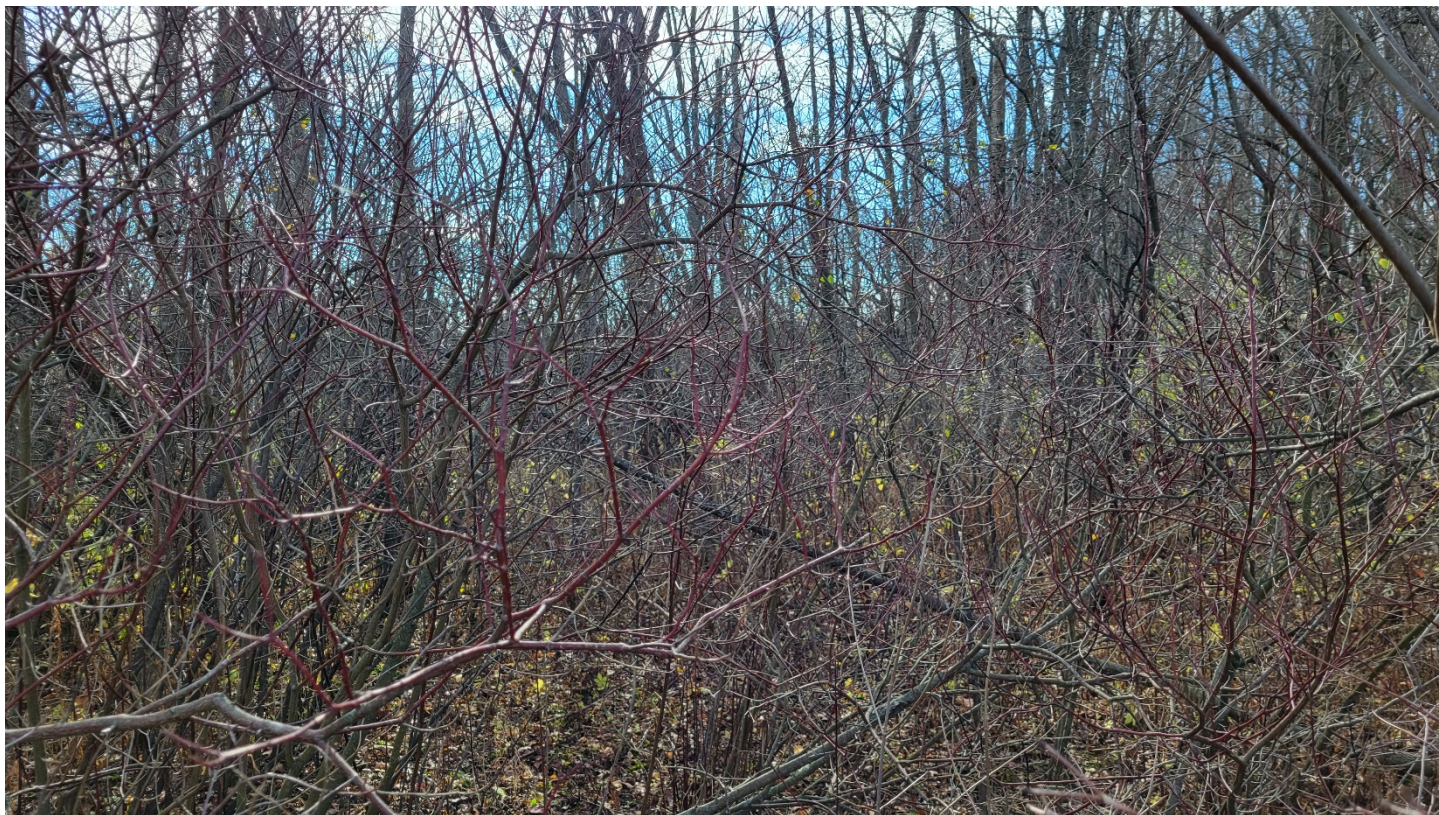
View of Wetland B. DP3 was taken at the toe of slope and had dominant species which included green ash, common buckthorn, white avens, and river bank grape.

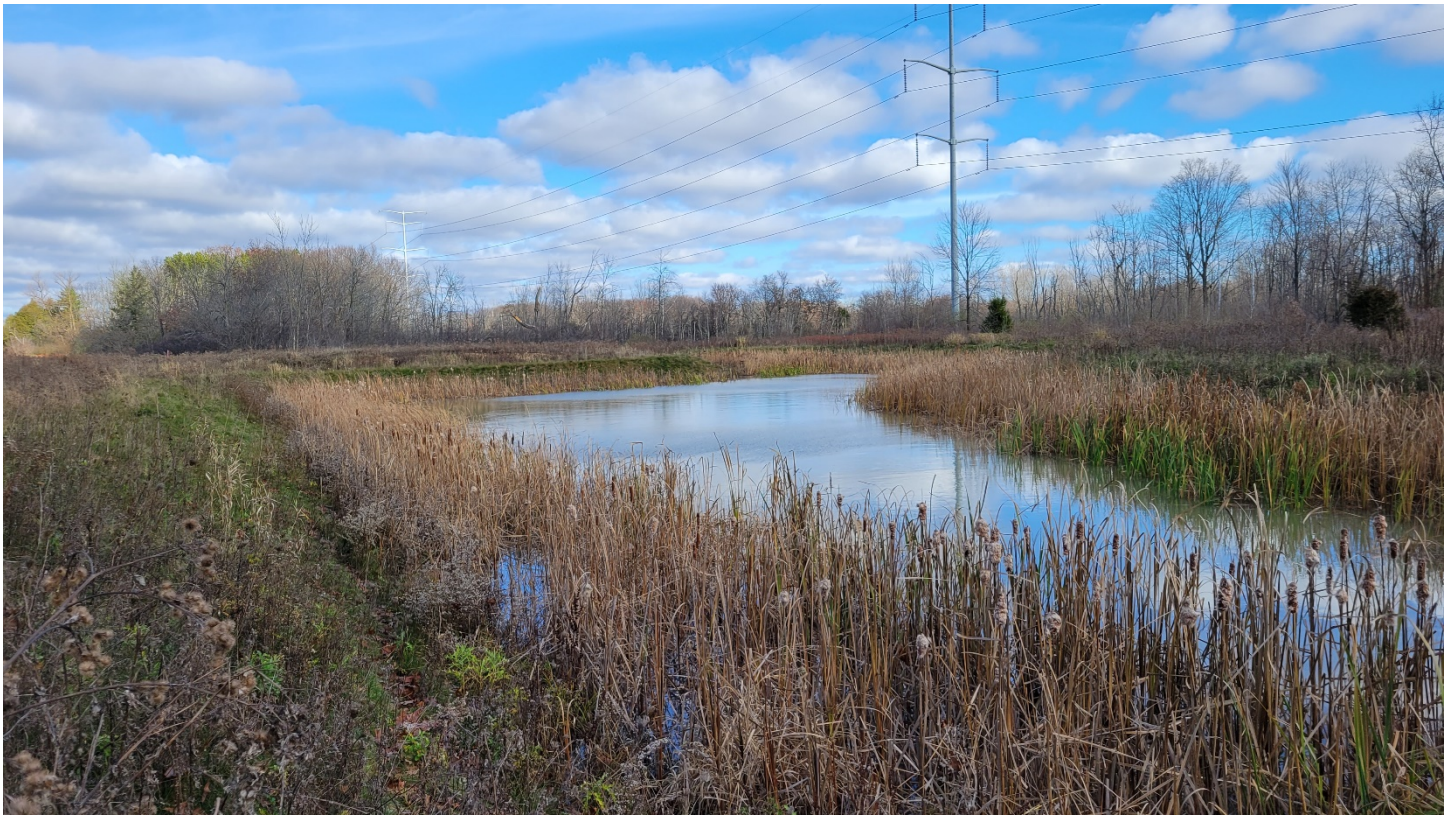
Wetland C is an open stormwater pond with an emergent wetland fringe. The dominant species was narrow-leaved cattail.

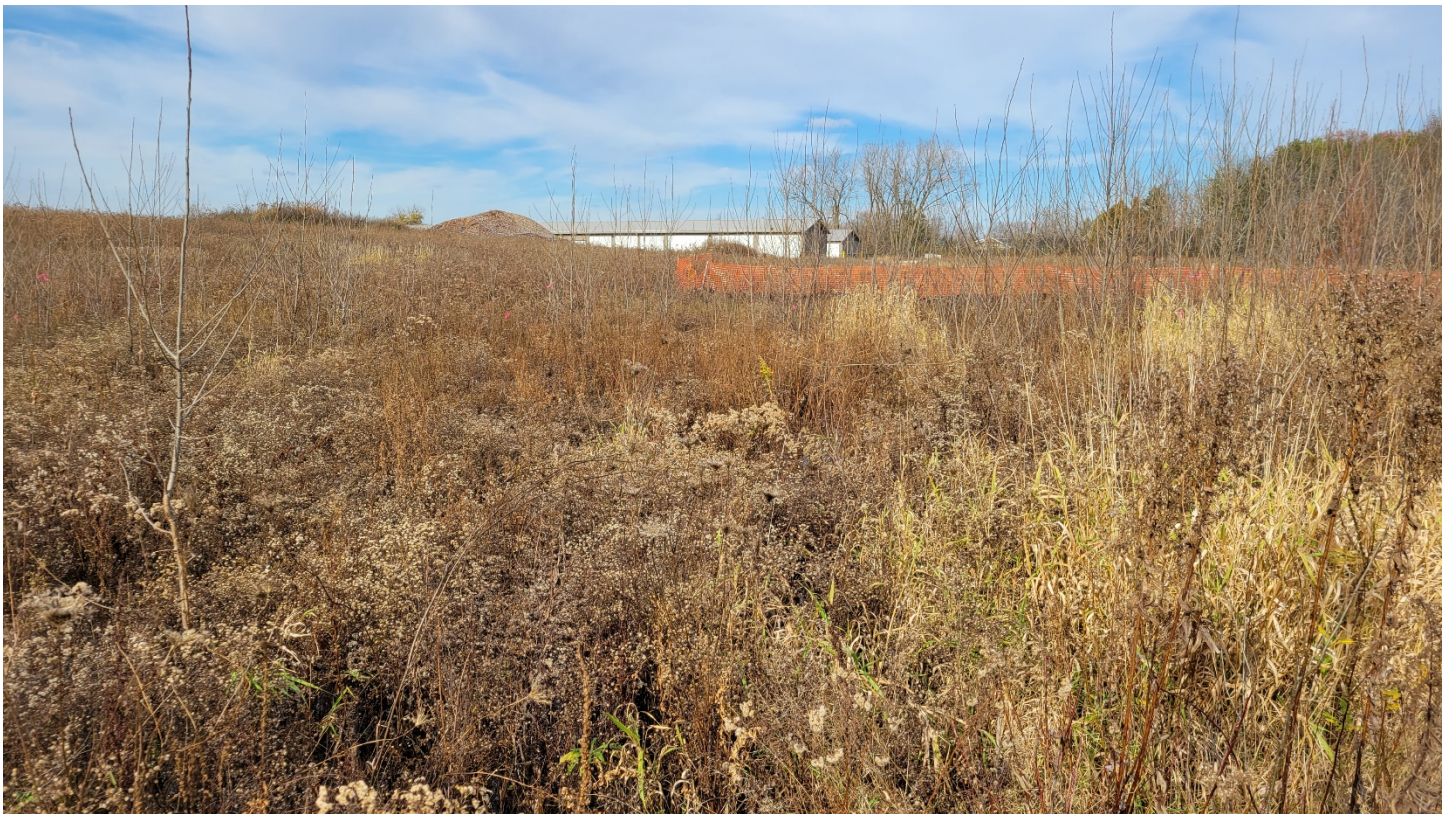
View of Wetland D, which was a disturbed wet meadow wetland dominated by eastern cottonwood, purple loosestrife, and reed canary grass.

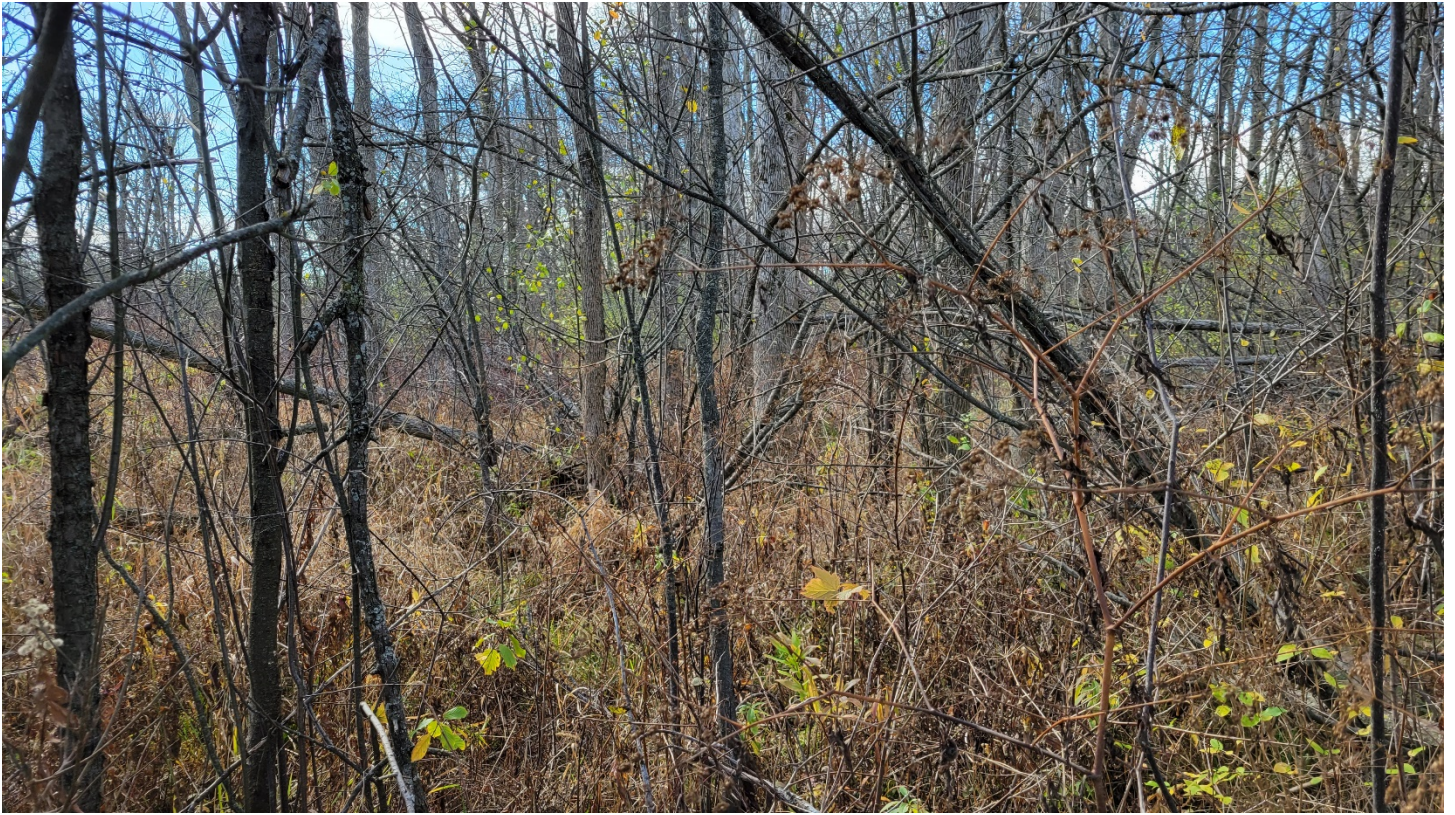
Wetland E is a disturbed forested wetland along the southeast boundary of the parcel.

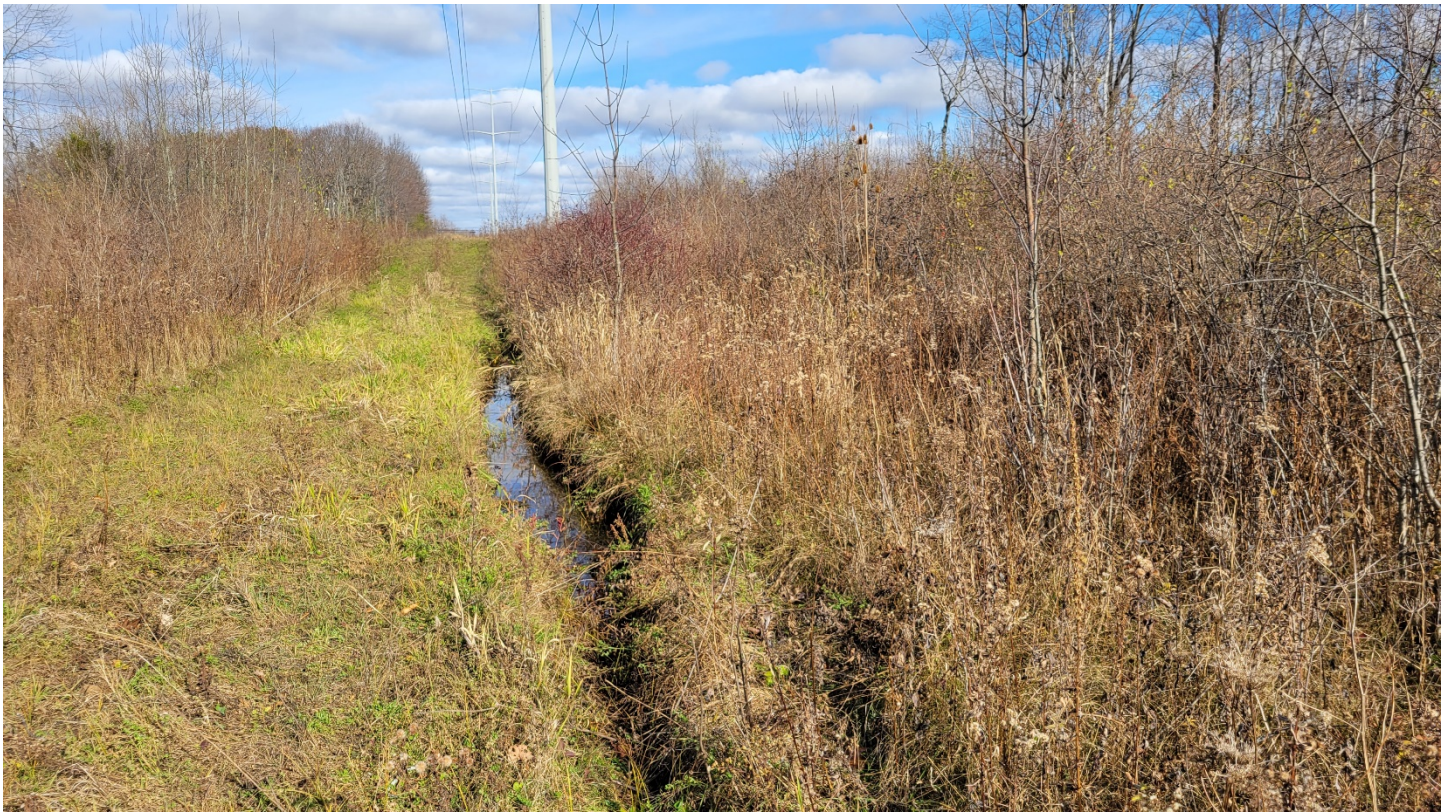
Wetland F is a disturbed wet meadow wetland under the power lines along the east boundary of the site.
